**A STUDY OF THE CONDITION OF
PIEZOMETERS IN THE 1949 INSTALLATION
AT REID-BEDFORD, LOUISIANA**

J. L. McCall

November 1968

**U. S. Army Engineer Waterways Experiment Station
CORPS OF ENGINEERS
Vicksburg, Mississippi**

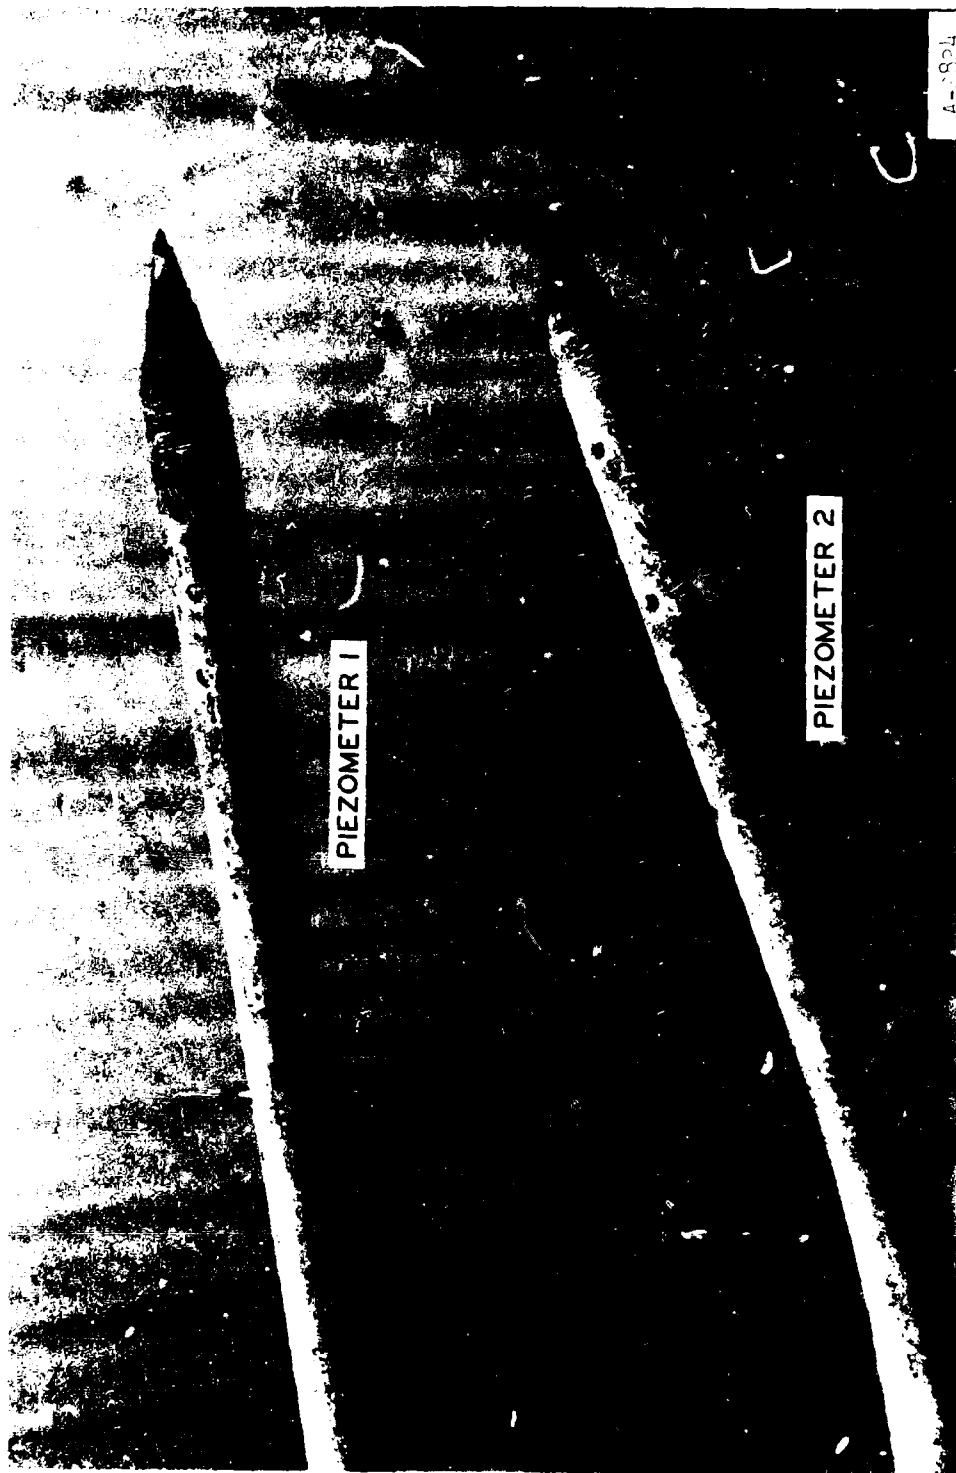
15. The tips of piezometers 1, 2, 6, and 10 were the only ones recovered; the driving tips of piezometers 14 and 15 were not recovered. The tips of piezometers 1, 2, and 10 were clogged. The WES hydrostatic pressure cell (diaphragm-strain gage type) was not recovered except for fragments of electrical cable broken off during the recovery attempt.

20. Drive point piezometers 1 and 2 were found to be completely clogged. In the 1949 study these two piezometers were operated as closed systems and consistently showed pressures indicating water elevations at or above the natural ground surface (approximately el 82). At the time, the high readings were attributed to an accumulation of gas in the piezometers. It is probable that these piezometers became clogged during driving and have never functioned properly. The other two drive point piezometers, 14 and 15, were found to be partially clogged, although piezometer 15 gave readings only slightly higher than the piezometers considered to be still giving satisfactory data. It was noted in the 1949 study that piezometers 14 and 15 were very slow in reacting to changes in hydrostatic pressure as compared to the reactions of the other open-system piezometers. It is probable that these piezometers have also been clogged to some extent ever since installation.

Photograph 1. U. S. Bureau of Reclamation drive point piezometers 1 and 2

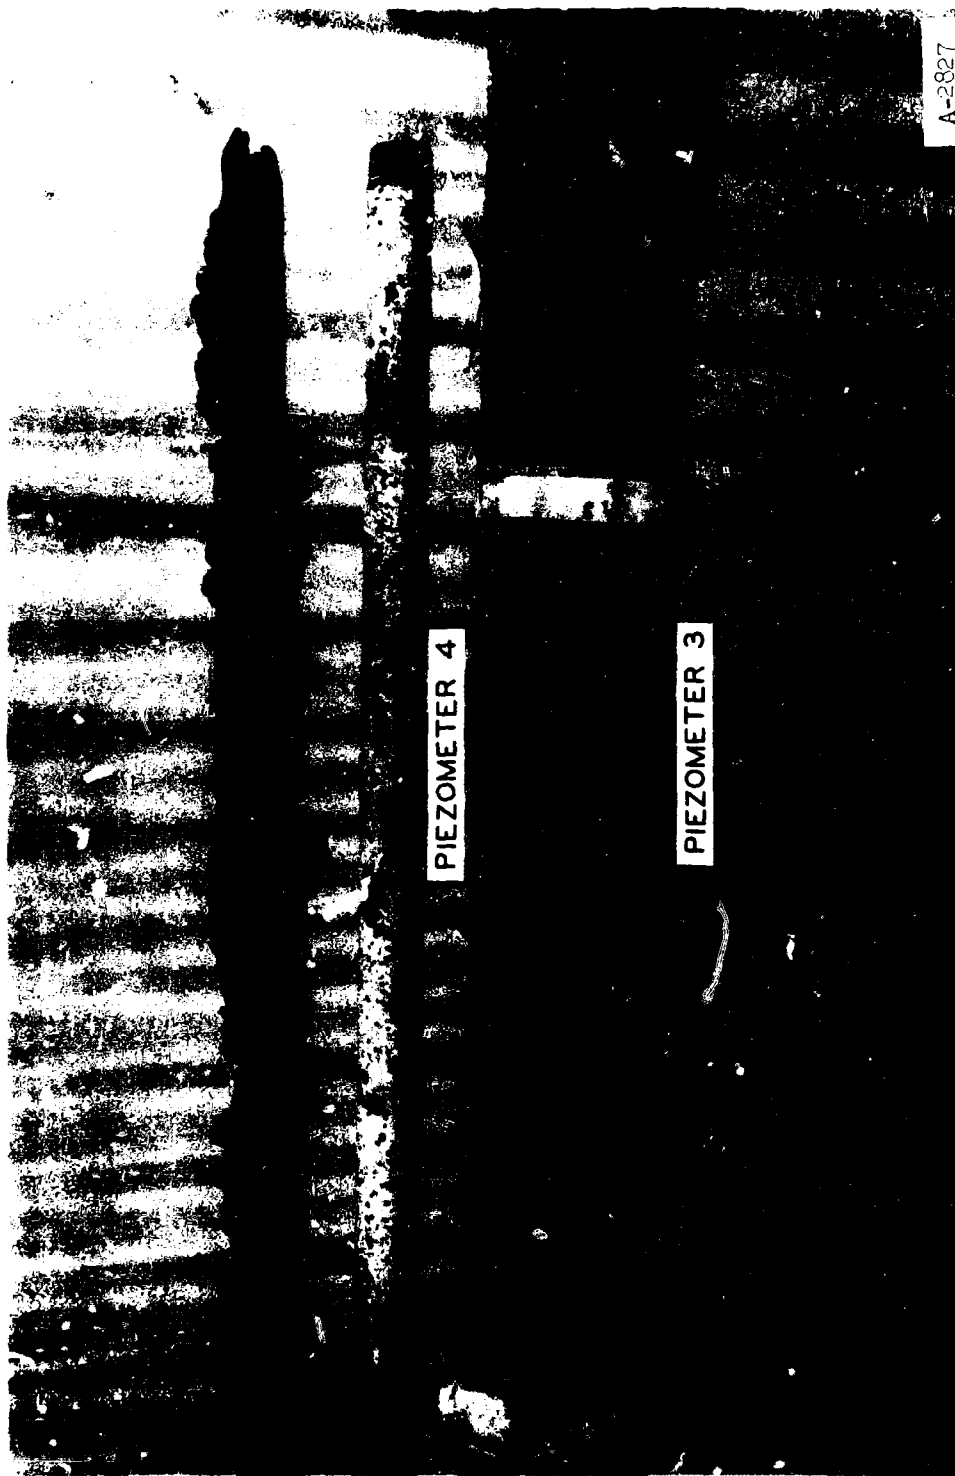
Photograph 2. Standpipes from Cherry Creek piezometers 3 and 4

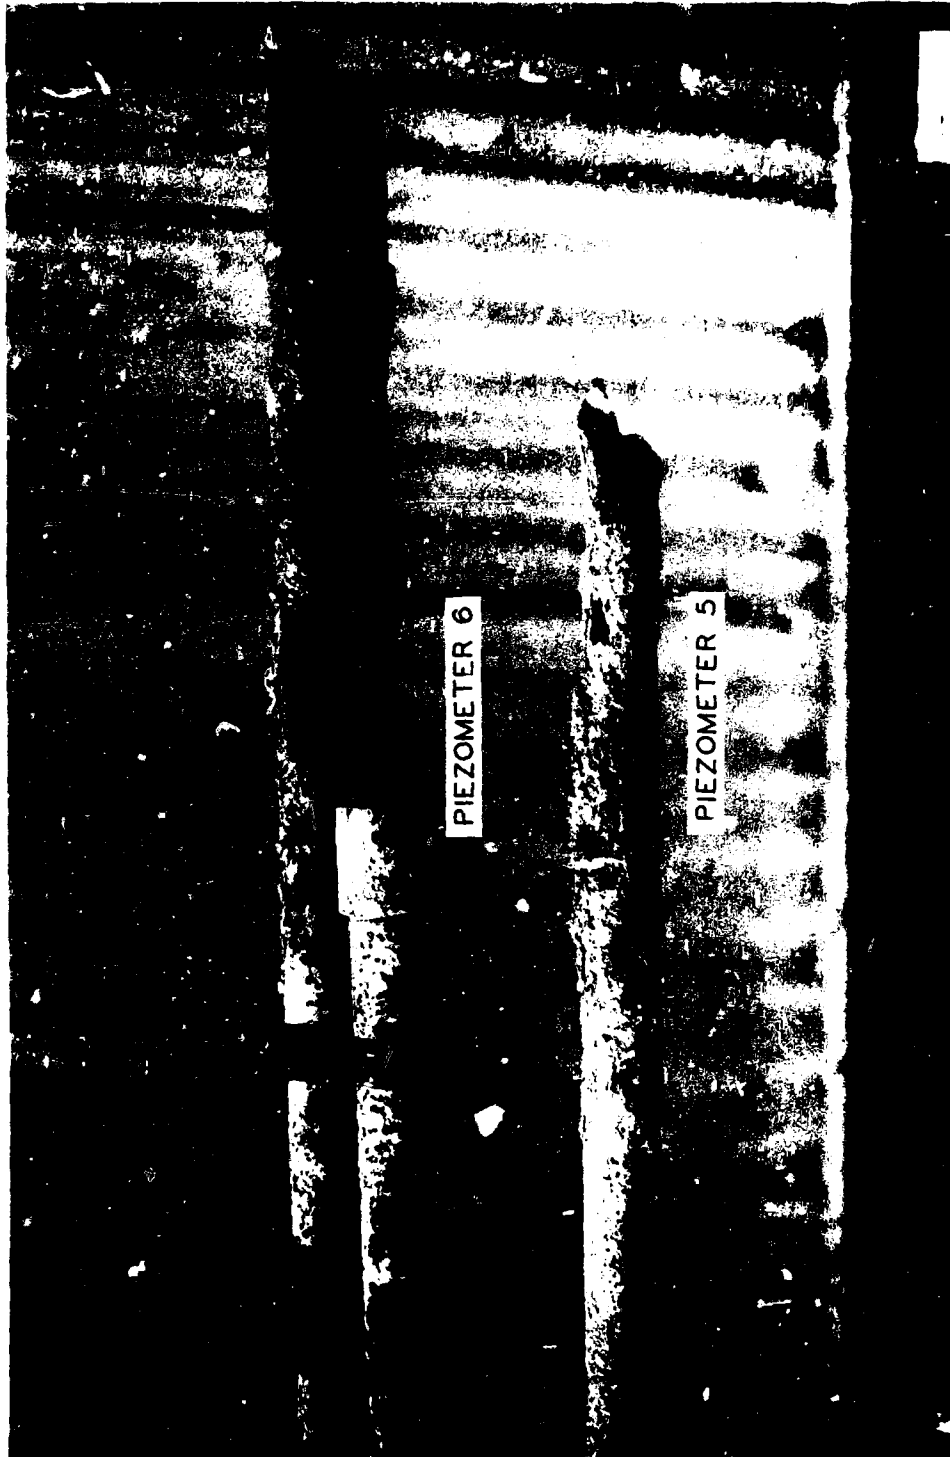
14. The total installed lengths of the standpipes of piezometers 1, 2, 6, 10, 14, and 15 were recovered. The standpipes of piezometers 6 and 10 were badly corroded, while the standpipes of piezometers 1, 2, 14, and 15 showed little or no evidence of corrosion. The lower ends of standpipes of piezometers 14 and 15, which had been in contact with the drive point, showed some brooming as a result of driving during the installation. The standpipes of piezometers 3, 4, 5, and 1A were so badly corroded that only portions of the standpipes were recovered. The total lengths of the protective iron pipes encasing the Saran tubing standpipes for Casagrande piezometers 7 and 8 were recovered and showed evidence of considerable corrosion. The Saran tubing standpipes for the Casagrande piezometers showed no signs of deterioration from age and appeared to be intact; however, mechanical damage occurred during the recovery attempt. The lower 5 ft of the standpipes for piezometers 1 and 2 were seen to be bent in a spiral when recovered; it is presumed that the standpipes were bent during the recovery operation.

Photograph 3. Standpipes from Cherry Creek piezometers 5 and 6

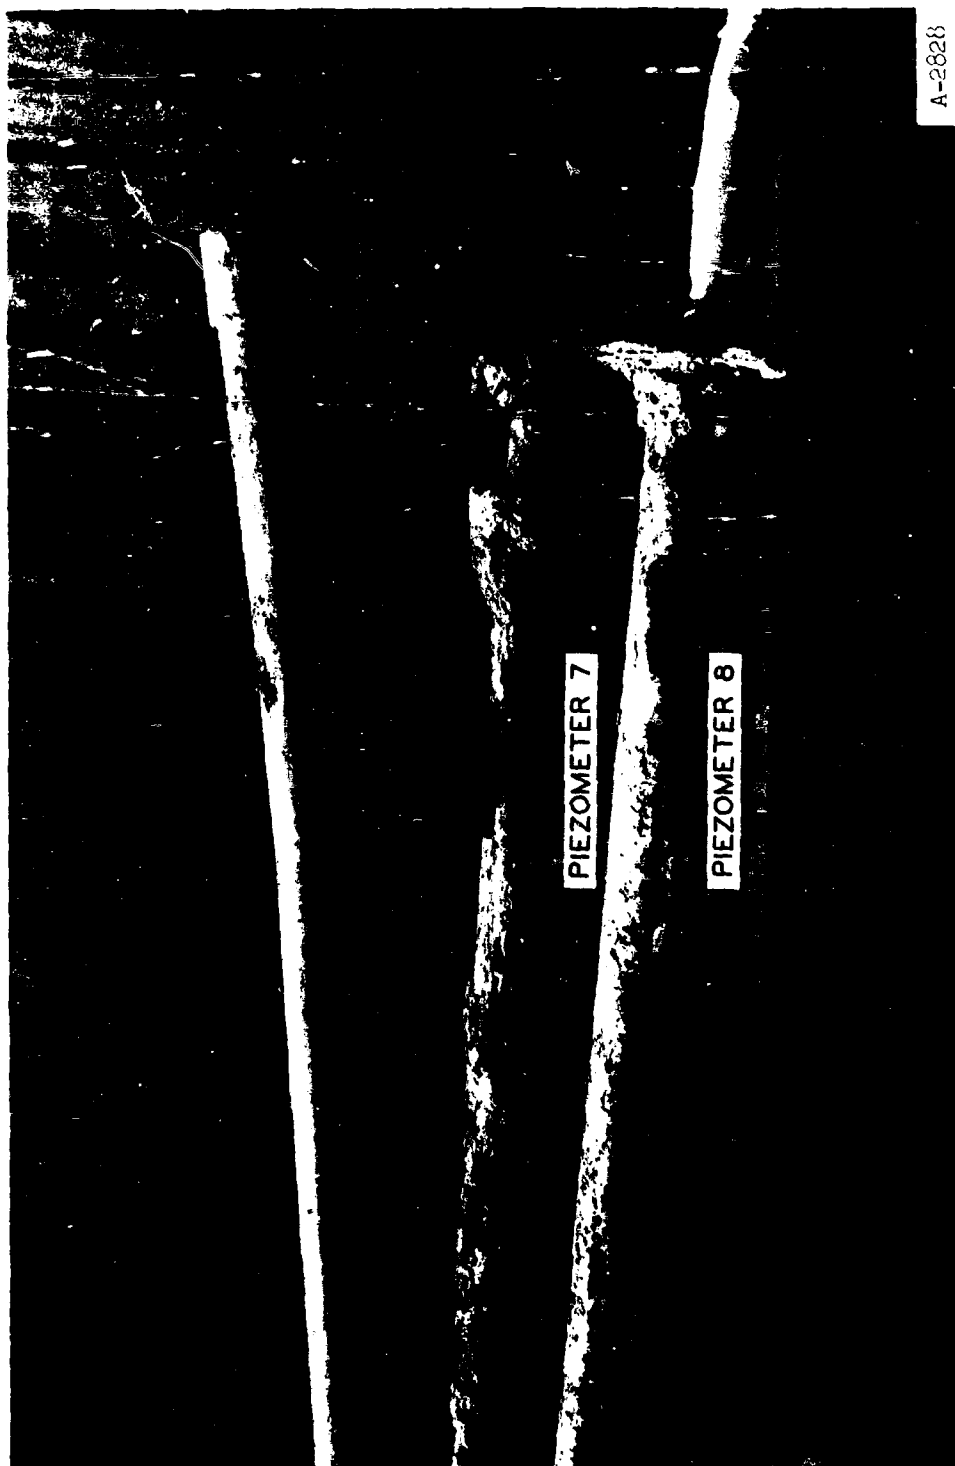
Photograph 5. Standpipes from Casagrande piezometers 7 and 8 with Saran tubing attached to 8

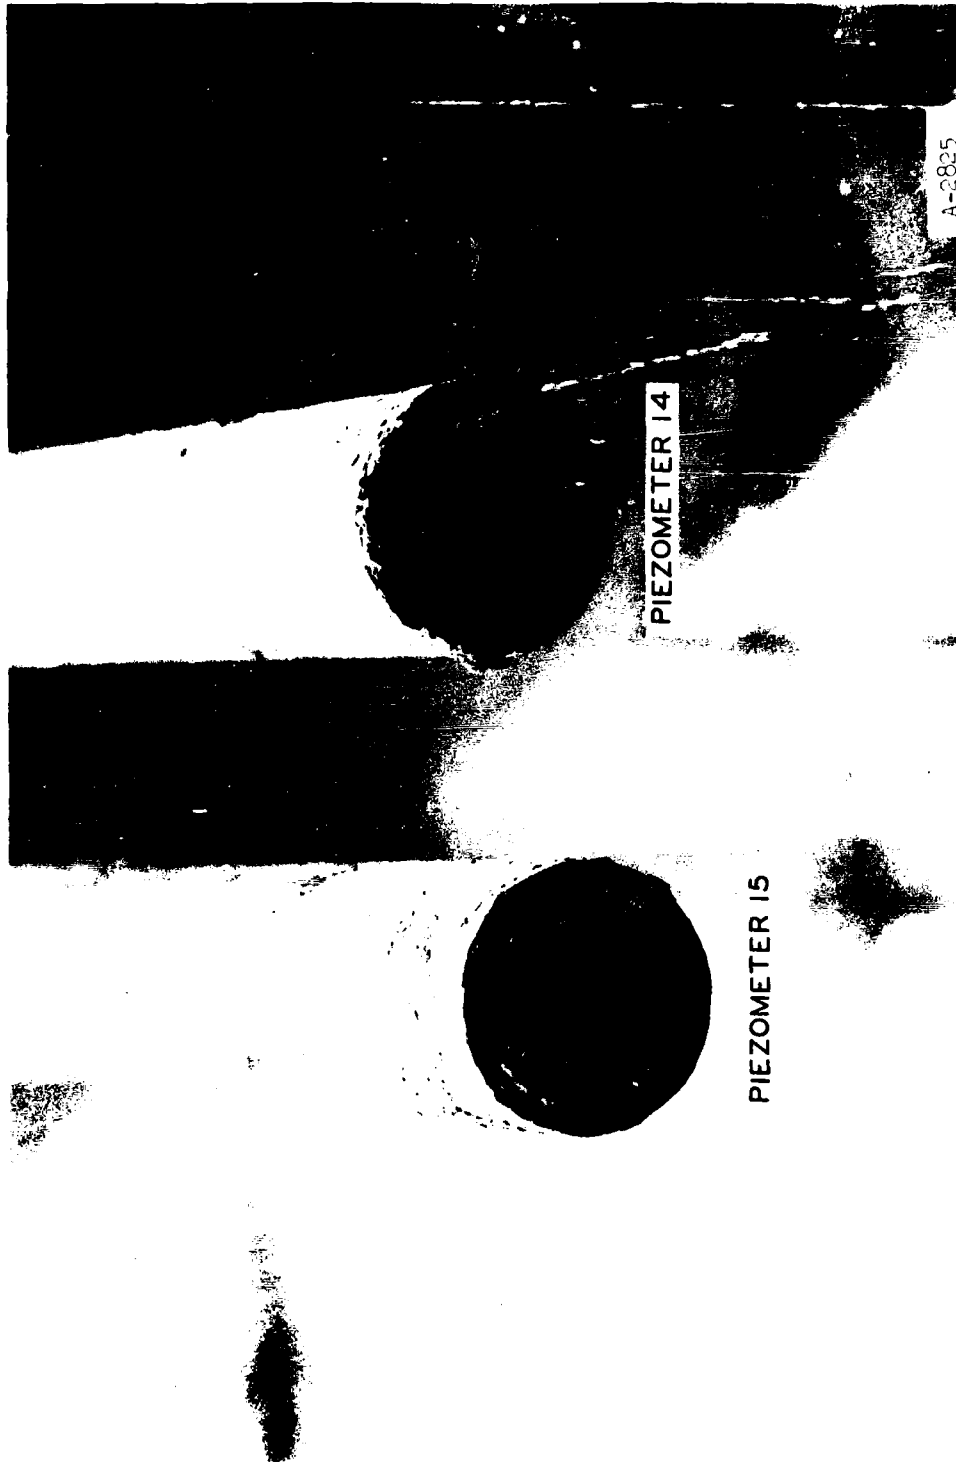
Photograph 7. Drive point piezometers 14 and 15
